Cayman Islands Government

# Landfill Site Environmental Review

## Task 2: Environmental Investigations Interpretative Report

9 March 2016

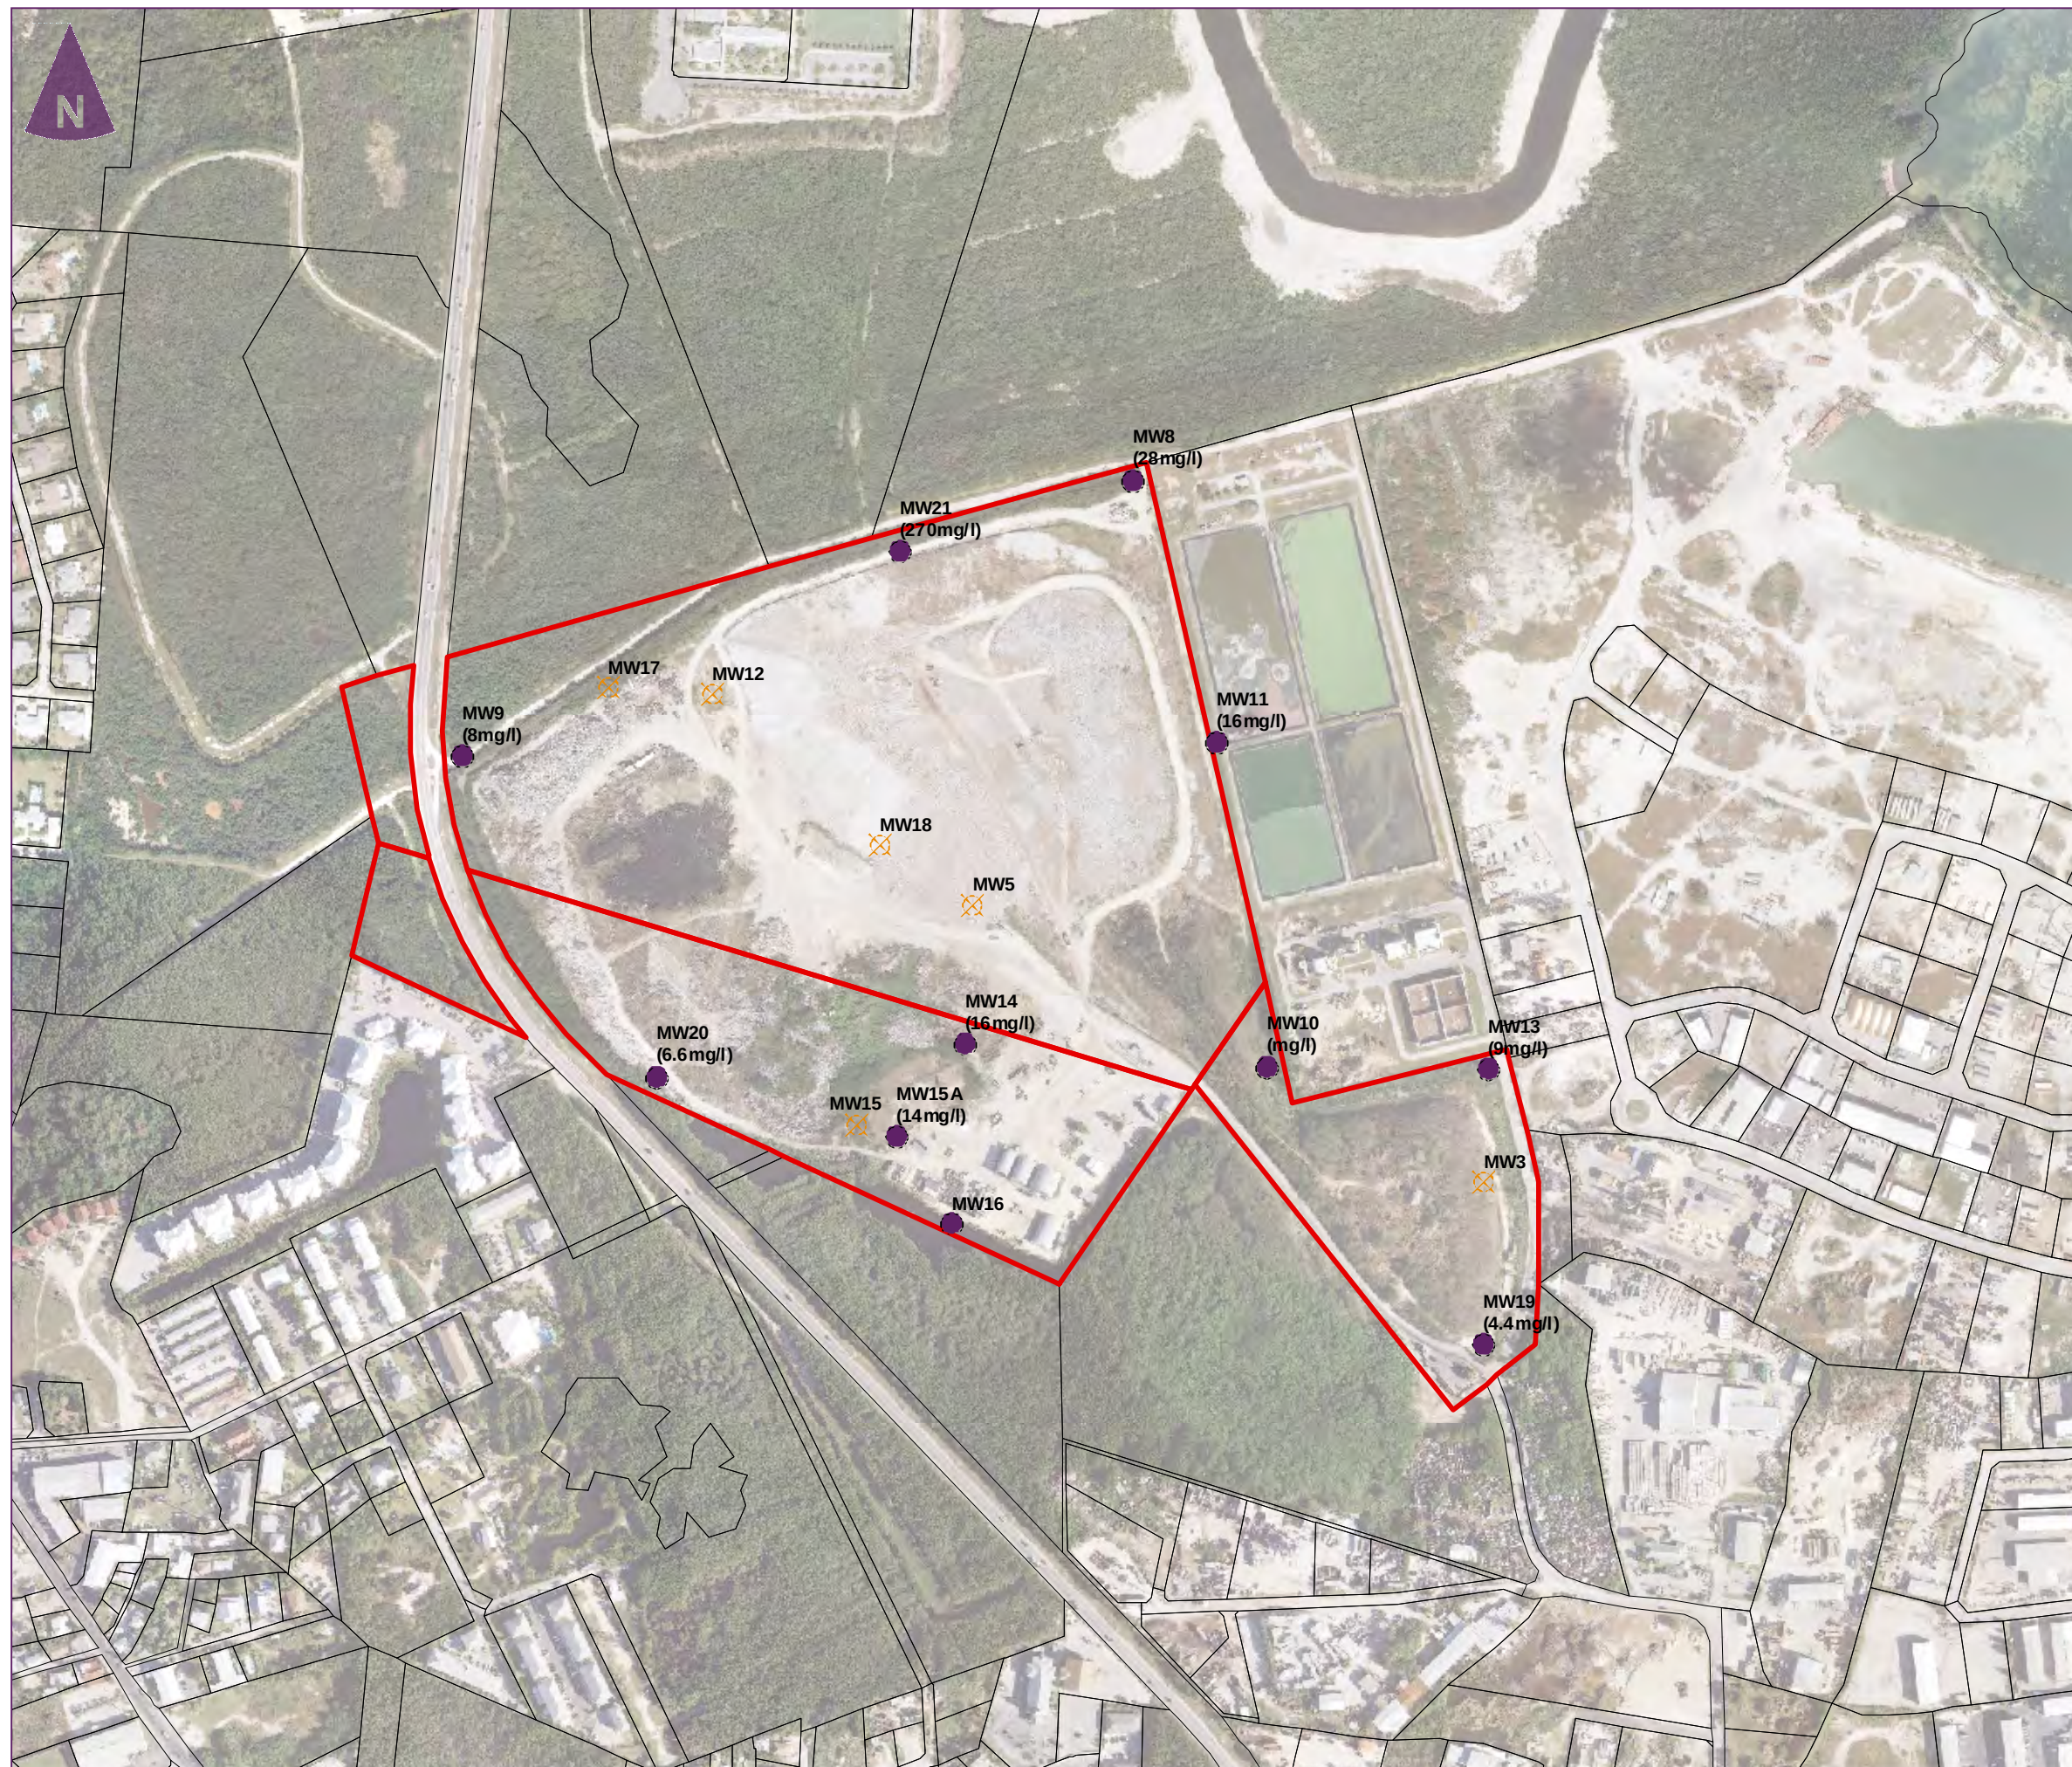
**Figure 3**  
**George Town Landfill**  
**Ammonia in Groundwater**

- Key
- Landfill Site Boundary
  - Groundwater Monitoring Well
  - Former Groundwater Monitoring Well

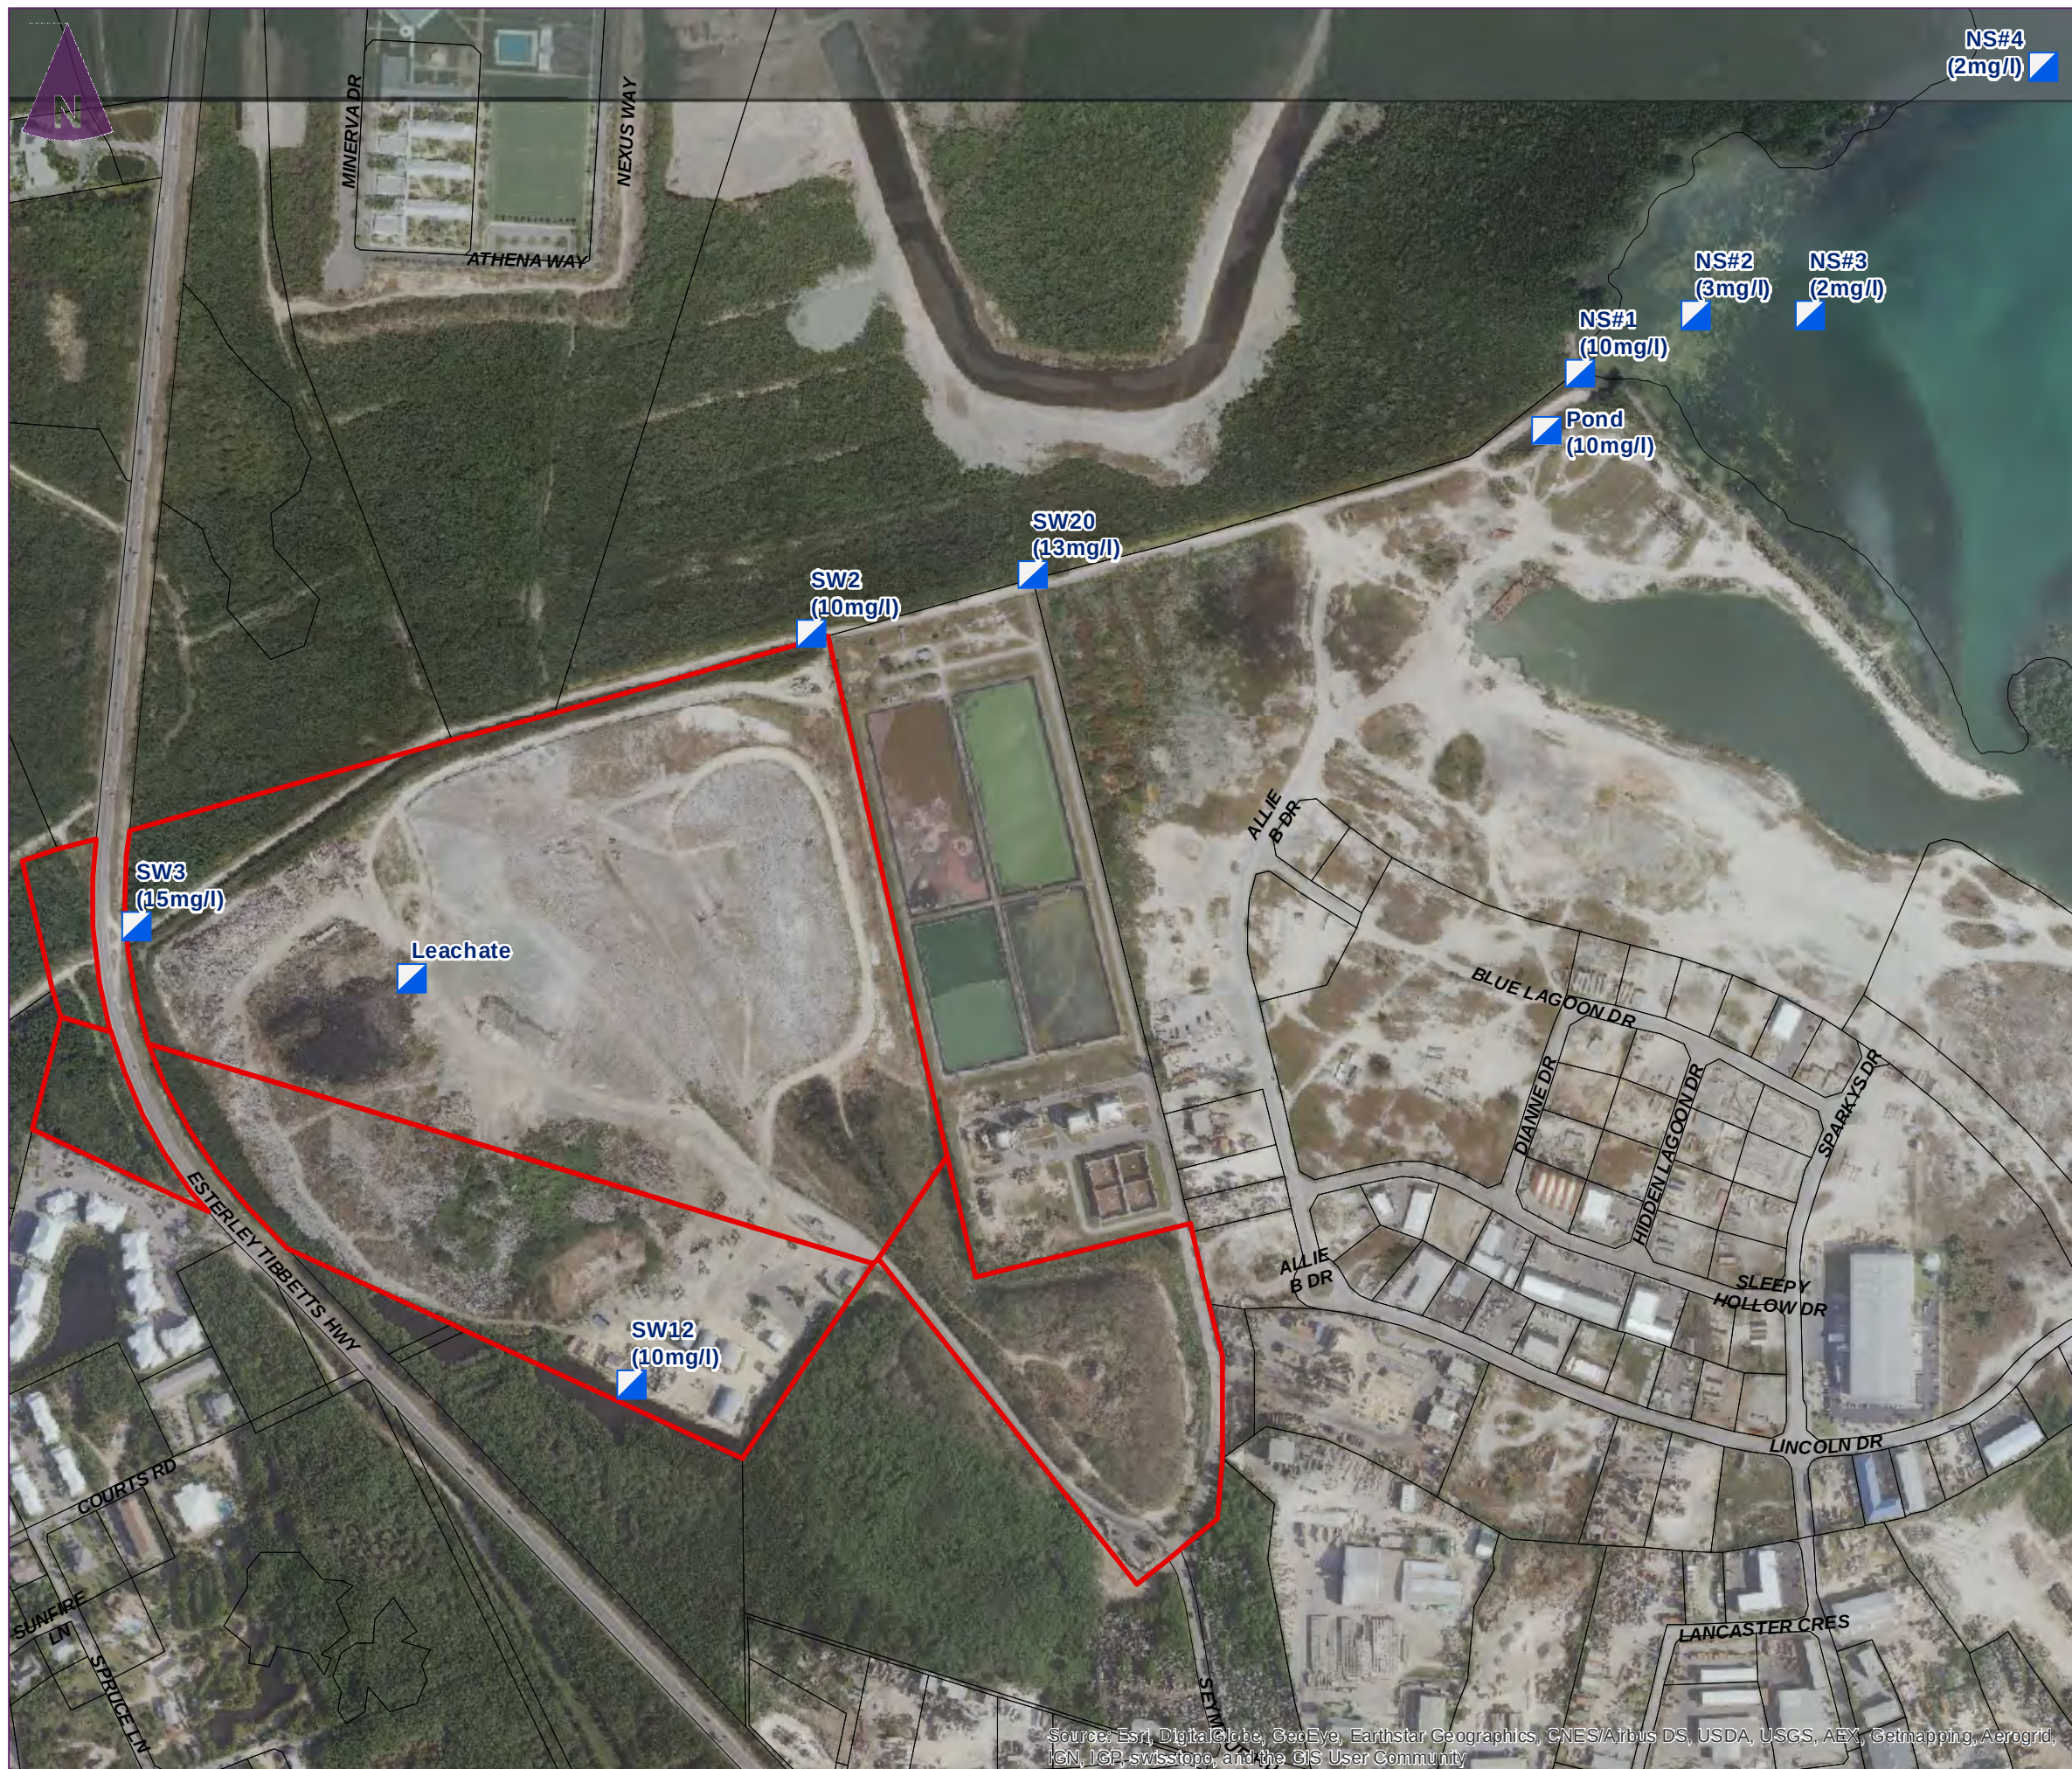
**Figure 6**  
**George Town Landfill**  
**Biochemical Oxygen Demand**  
**in Surface Waters**

- Surface Water Sampling Site
- Landfill Site Boundary

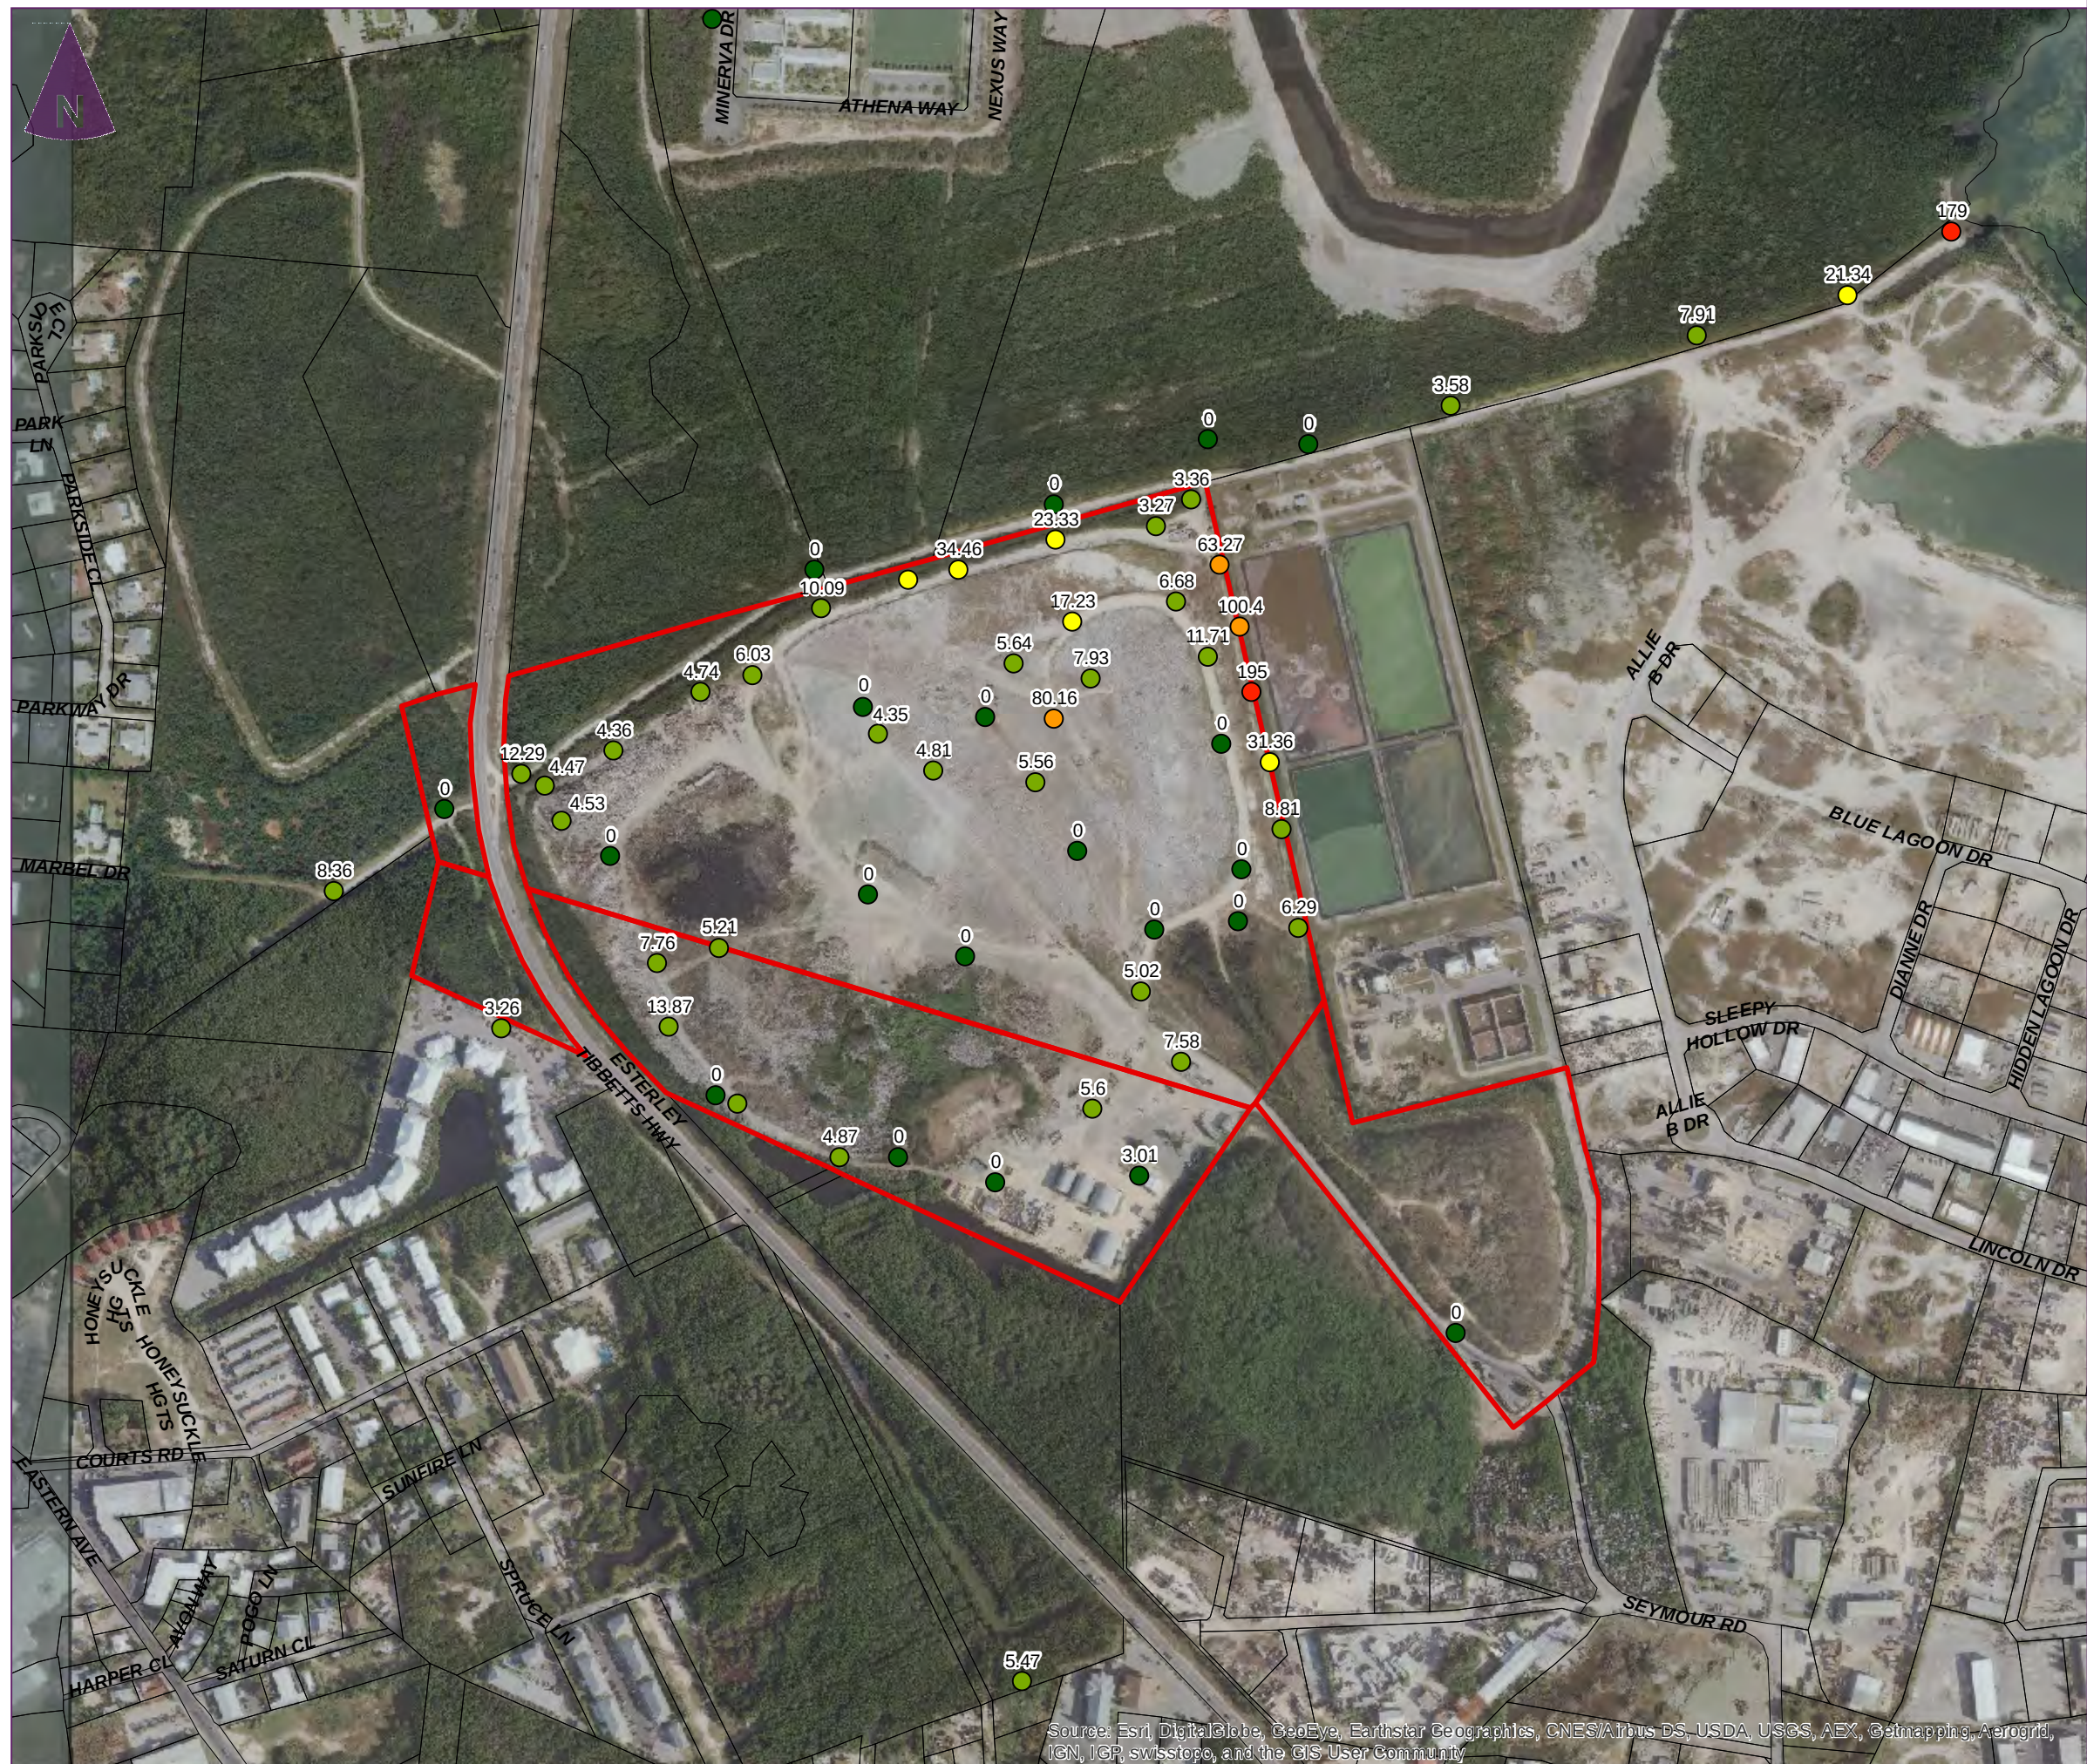
- Site Boundary
- H2S (ppb)
- 0.00 - 3.01
  - 3.01 - 13.87
  - 13.87 - 34.46
  - 34.46 - 100.40
  - 100.40 - 195.00

Fugitive hydrogen sulphide measurements in air were undertaken on and adjacent to the George Town landfill site on 11 April and 18 April 2015, following the methodology set out in the Task 2 investigation factual report. The weather conditions during the duration of each survey was as follows:

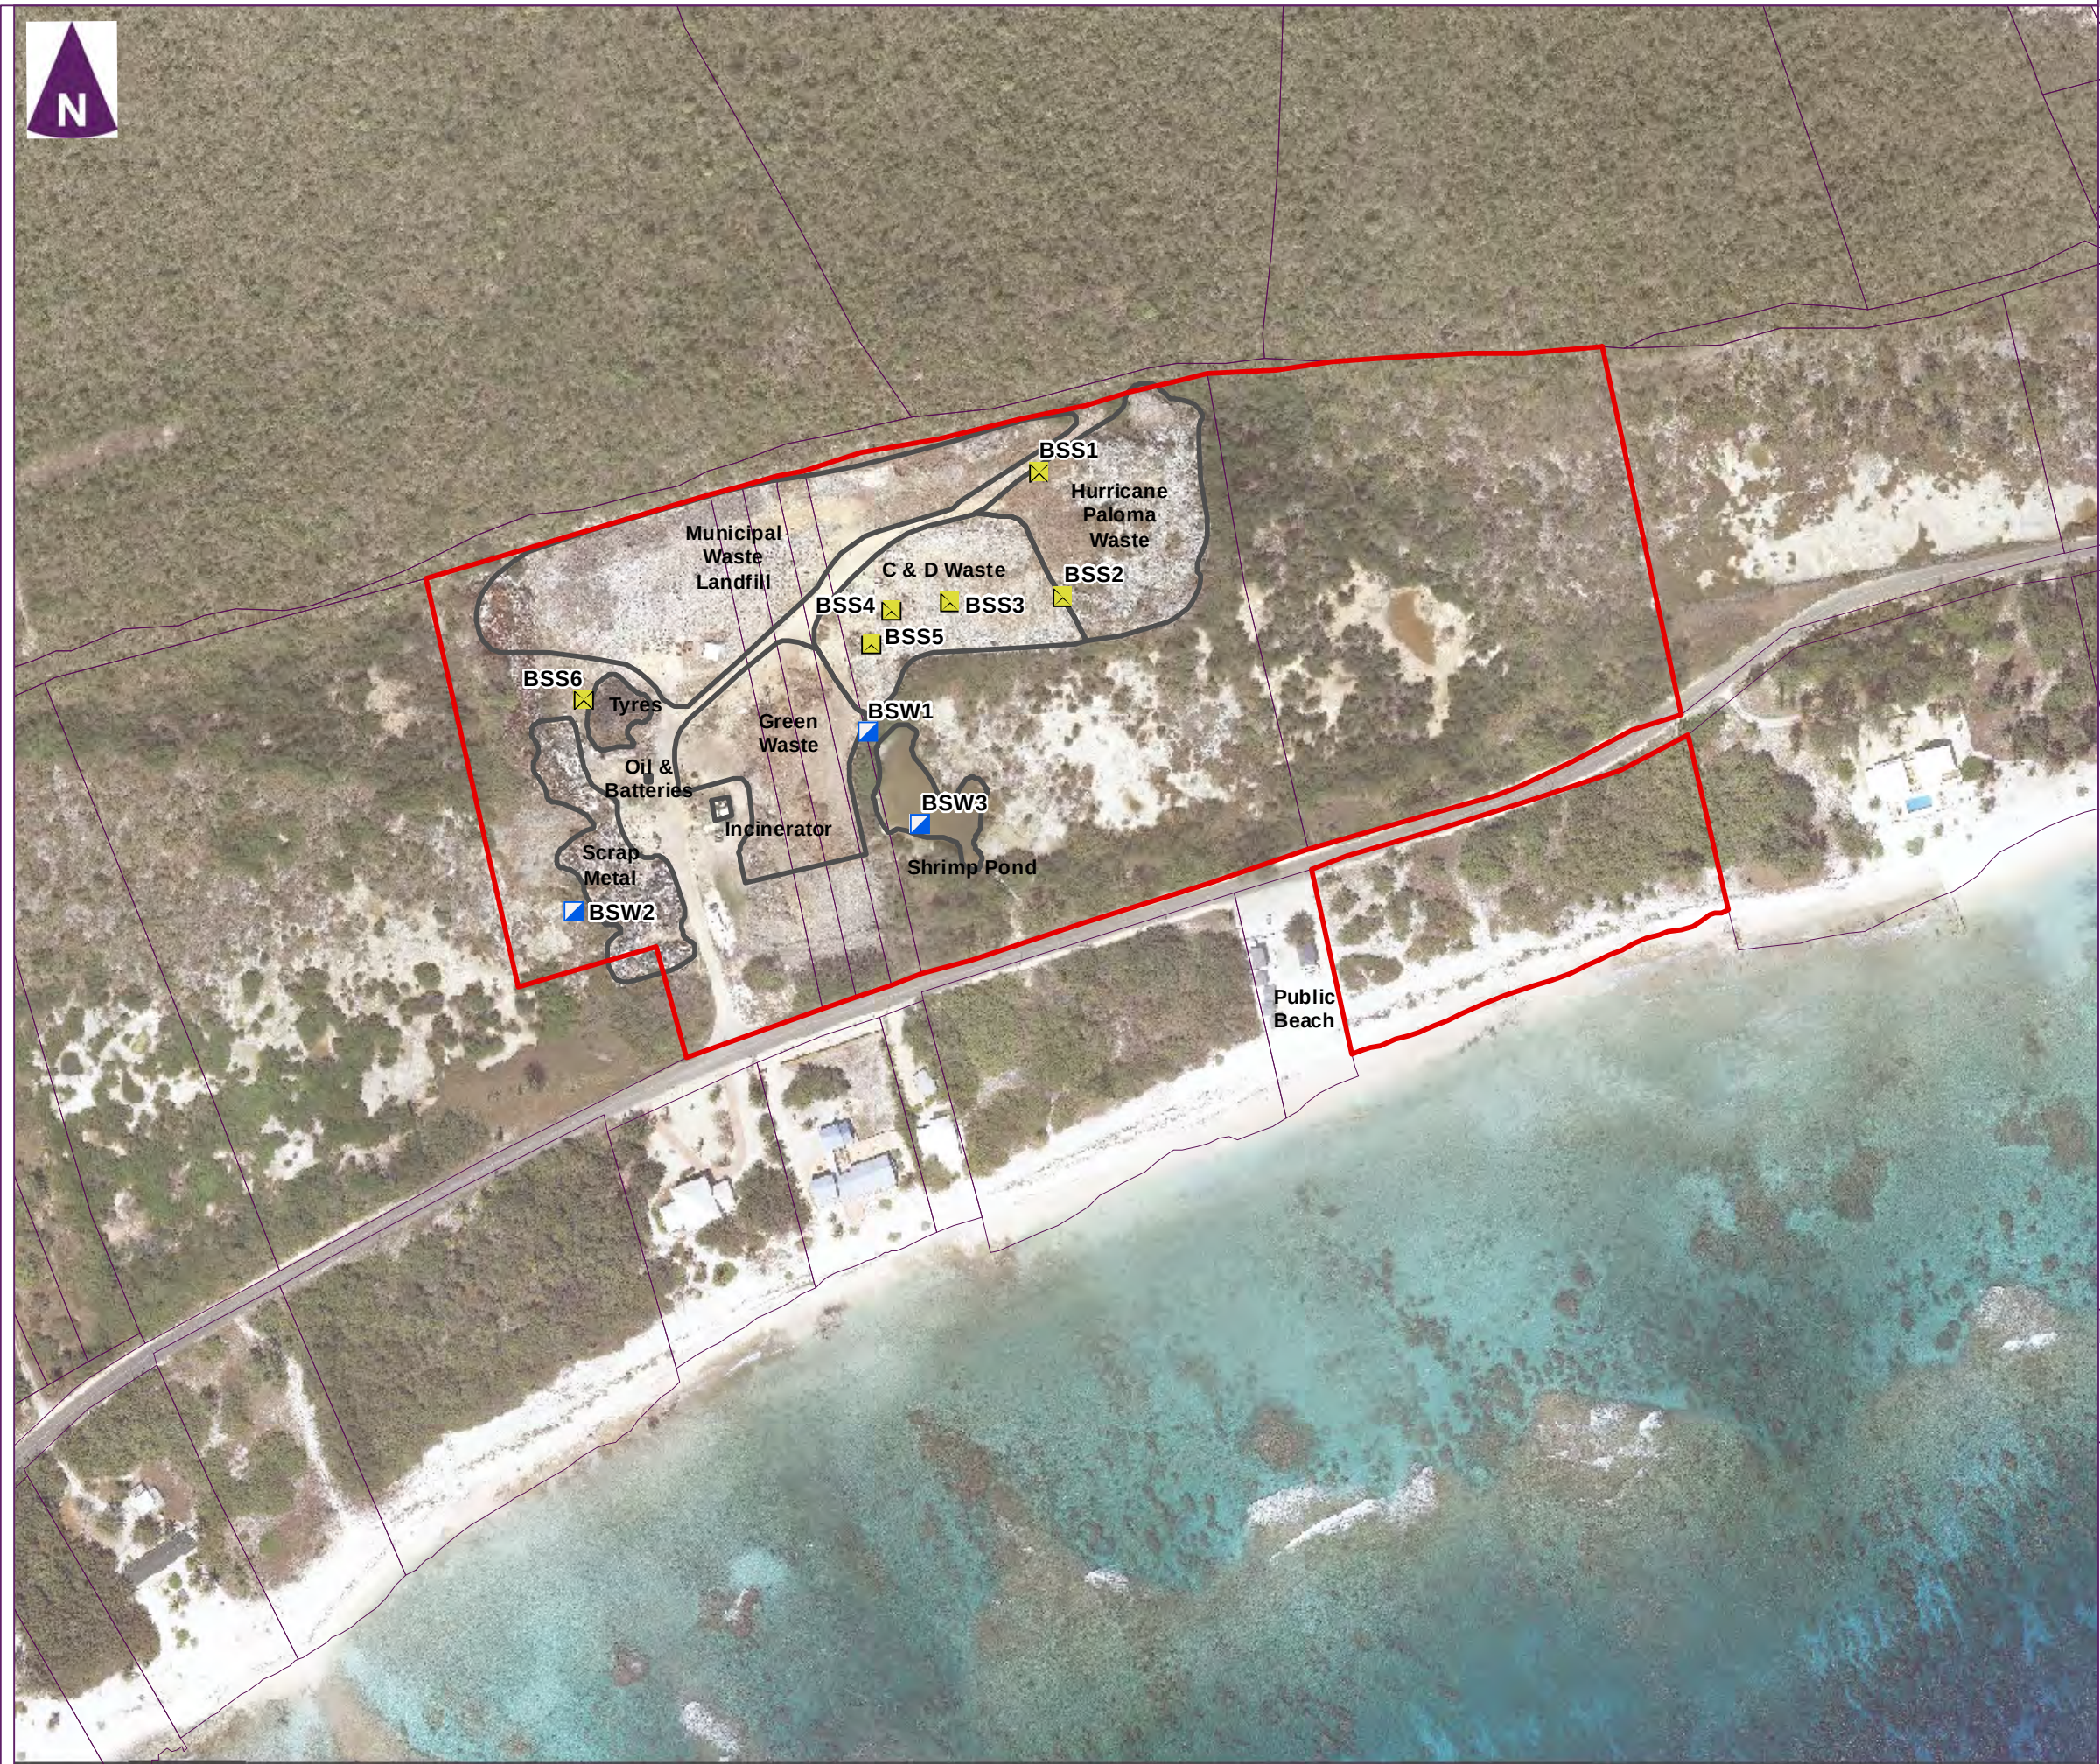
**Figure 20**  
**Cayman Brac Landfill**  
**Sampling Locations**

- Soil Sample Site
- Surface Water Sample Site
- Site Boundary
